CYCLIC AND LOW TEMPERATURE EFFECTS ON MICROCIRCUITS

FINAL TECHNICAL REPORT

AUGUST 1975 — AUGUST 1977

MCDONNELL DOUGLAS ASTRONAUTICS COMPANY - EAST

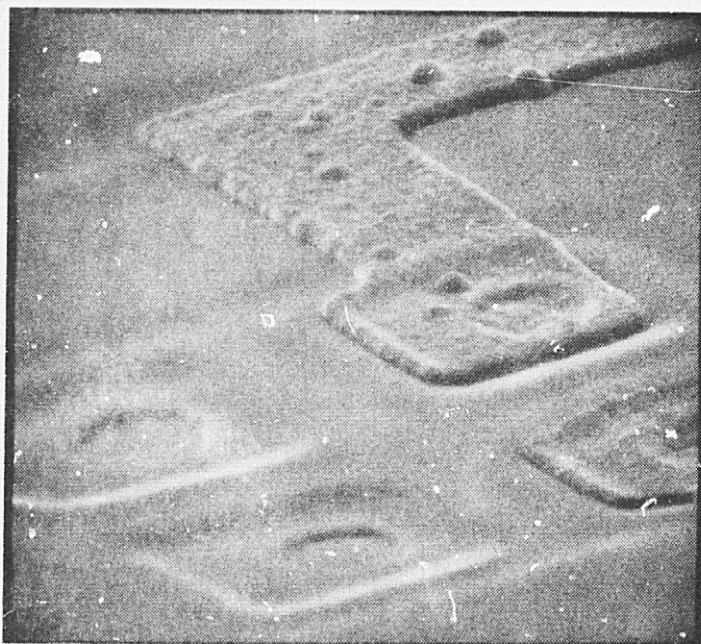
S/N 695

FIGURE A25. EXAMPLE OF GRAIN GROWTH (BUMPS) AND STEP COVERAGE (PRIOR TO GLASSIVATION REMOVAL).

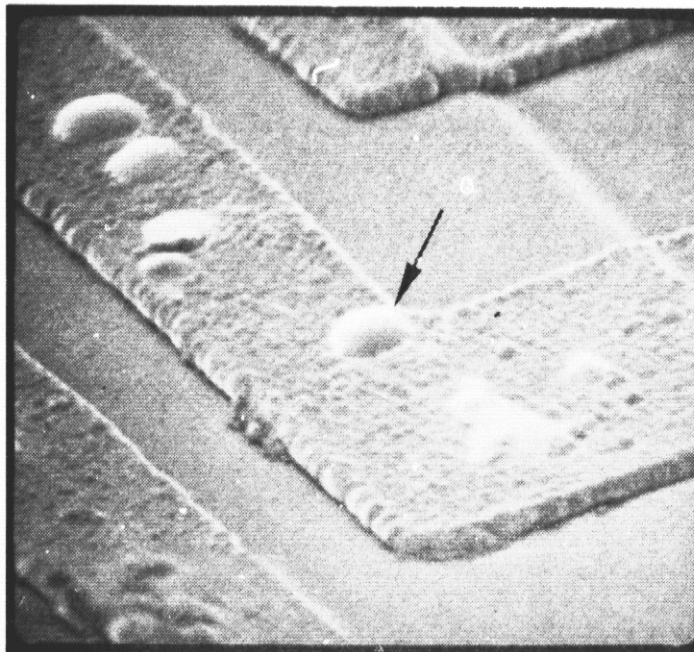
FIGURE C32. SEM CLOSE UP OF THE DROPLETS SHOWING THE INITIAL SHAPE OF THE DROPLET (ARROW) TO BE INVESTIGATED.
